NuMI Target Situation/Status

Proton Plan PMG
April 18, 2005
NuMI Target Situation
D. Bogert
Page 1

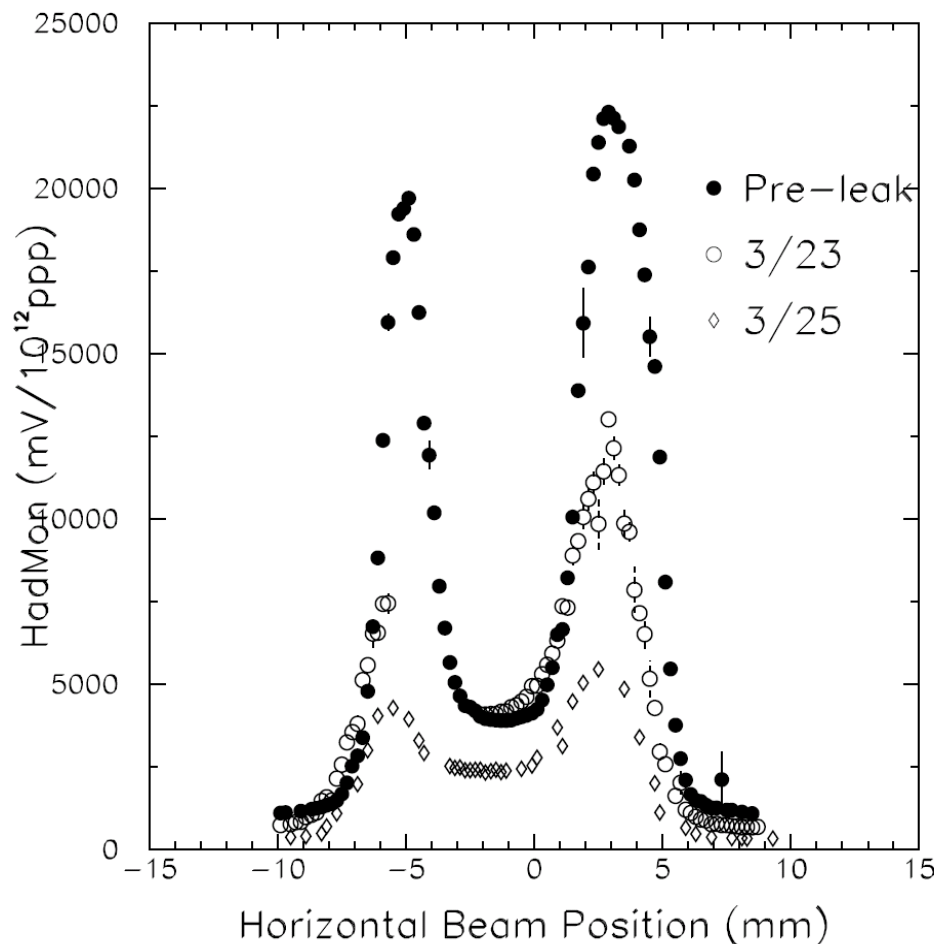
This plot shows the results of Horizontal Scans across the target. Transmission to the Hadron Monitor just before the absorber is plotted. On the left the beam is completely absorbed by the baffle. Then the beam crosses the vacuum space between the target and baffle, maximizing transmission, and then hits the target, and repeats in reverse to the right.

Note that transmission falls in successive scans as the target fills with water.

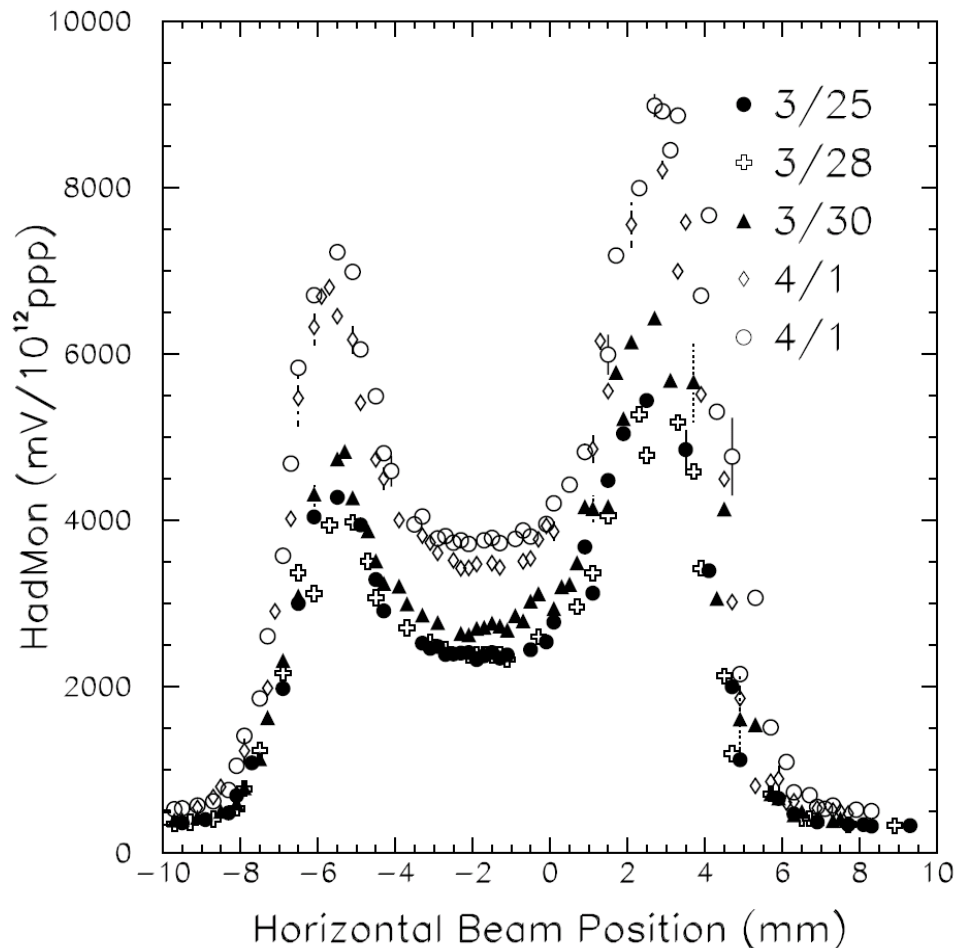
This plot shows the results of more Horizontal Scans across the target. Transmission to the Hadron Monitor just before the absorber is plotted.

Note that transmission rises in successive scans as some of the water is pushed out of the hole by over-pressurizing the vacuum space with Helium.

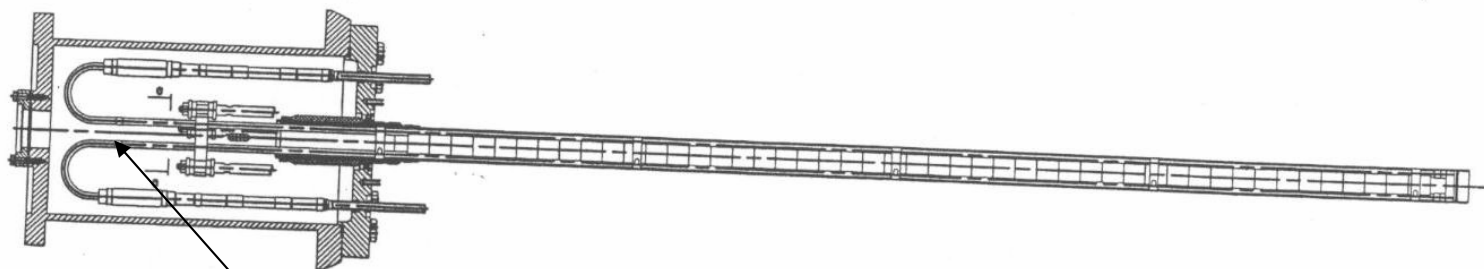
THE NuMI TARGET

Leak was thought to be here.

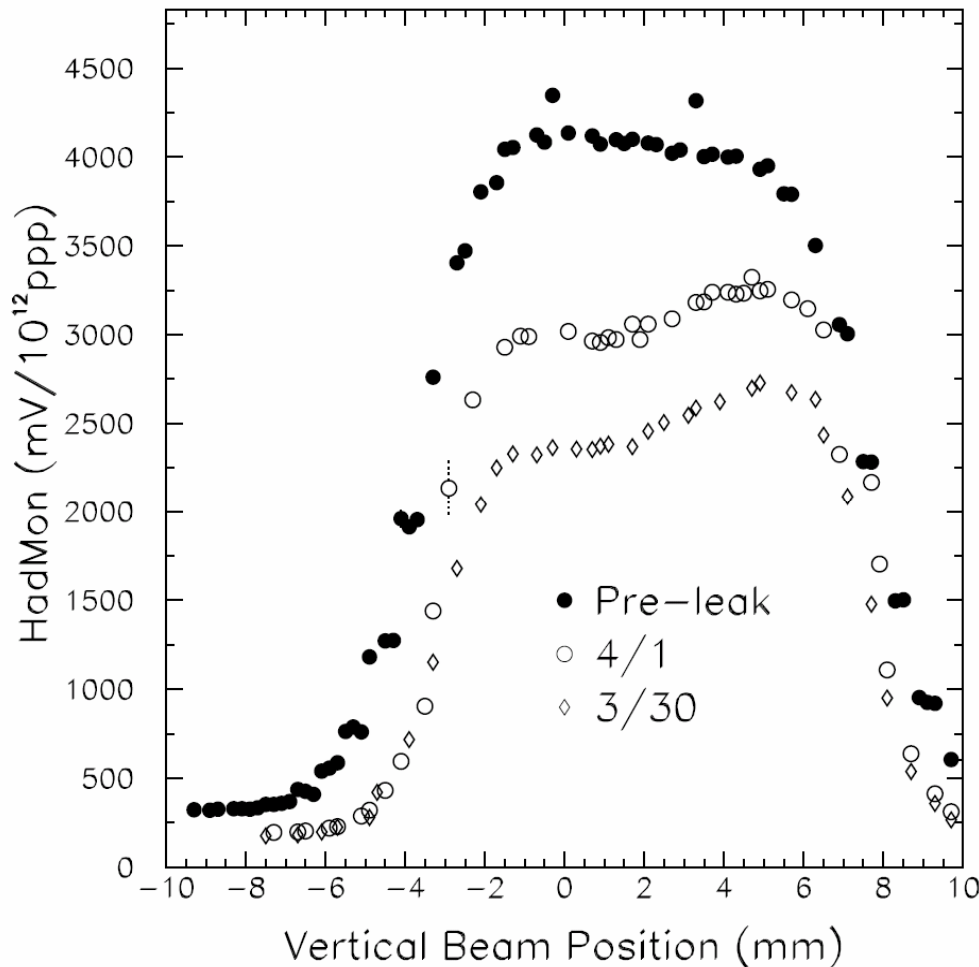
This plot shows the results Of Vertical Scan across the target. Transmission to the Hadron Monitor just before the absorber is plotted.

Note that transmission rises in successive scans as some of the water is pushed out of the hole by over-pressurizing the vacuum space with Helium.

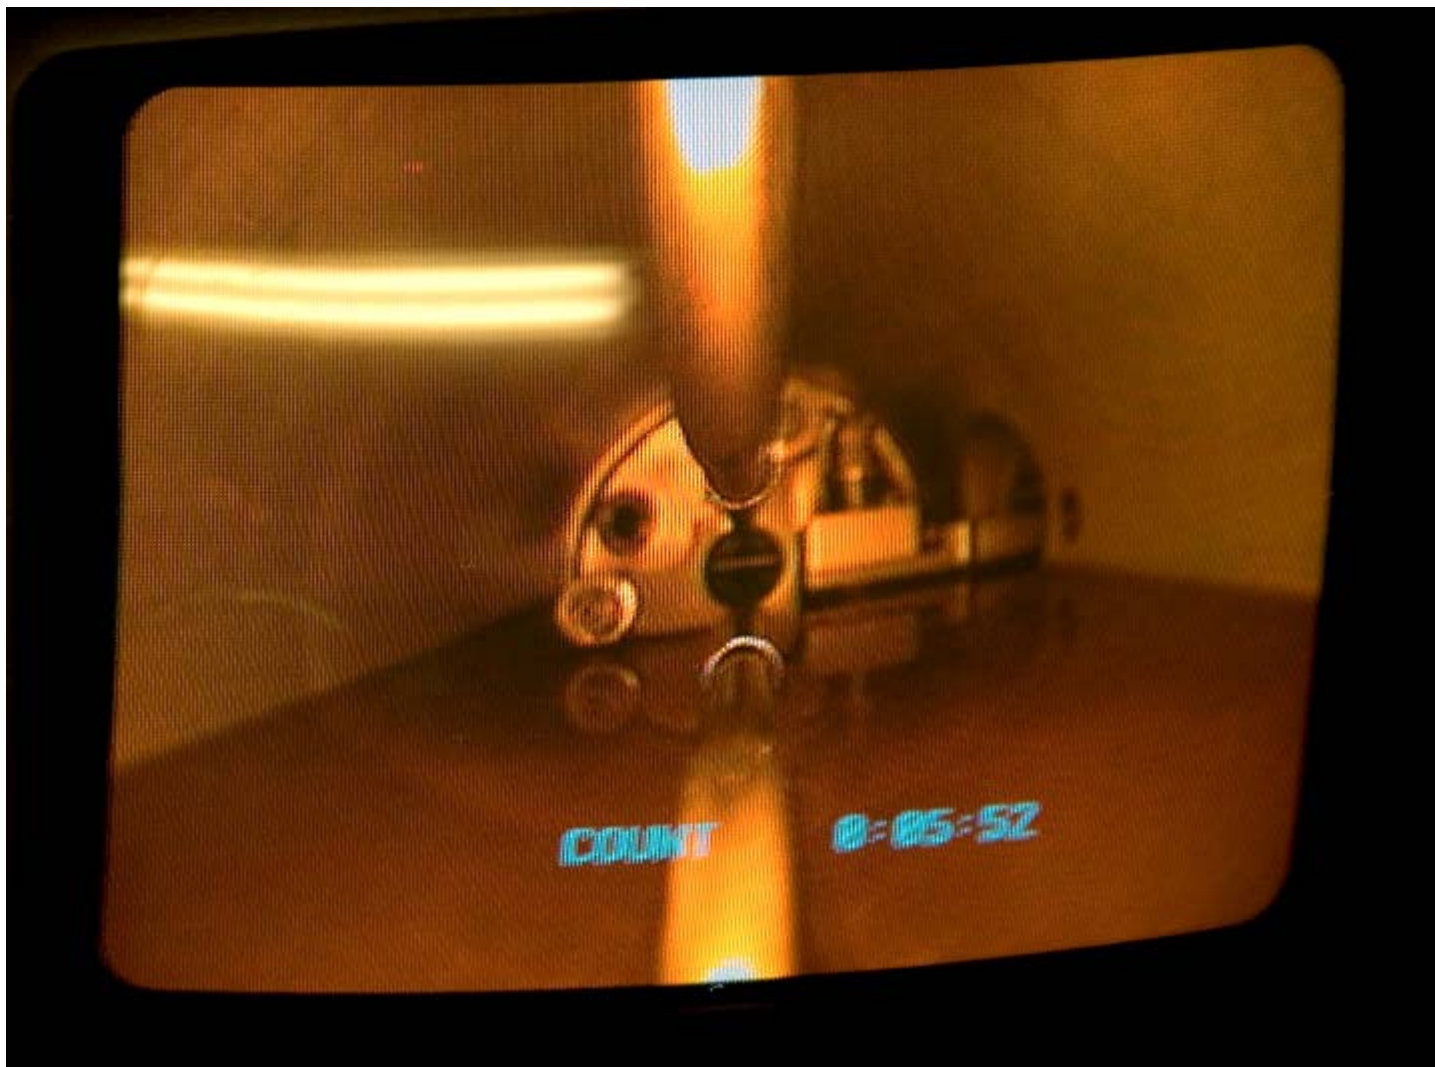
- 1) On Monday April 11 the removal of the upstream target baffle from the carrier, and the removal of the upstream beryllium window for access into the can region was completed. Total Staff exposure was under about 14mr for this work.**
- 2) Bore scopes were used to inspect the interior of the target can. Pictures of the bore scope monitor were recorded from the video tapes.**
- 3) On Tuesday April 12 the Alignment staff measured the locations of the target cooling tubes with respect to the nominal beam location. It was determined that they DID NOT extend into the beam region and WERE almost completely shadowed by the upstream baffle.**
- 4) Attempts to locate the leak, first with pressurized Helium, and then water in the cooling tubes have been unsuccessful; the leak appears to be plugged.**

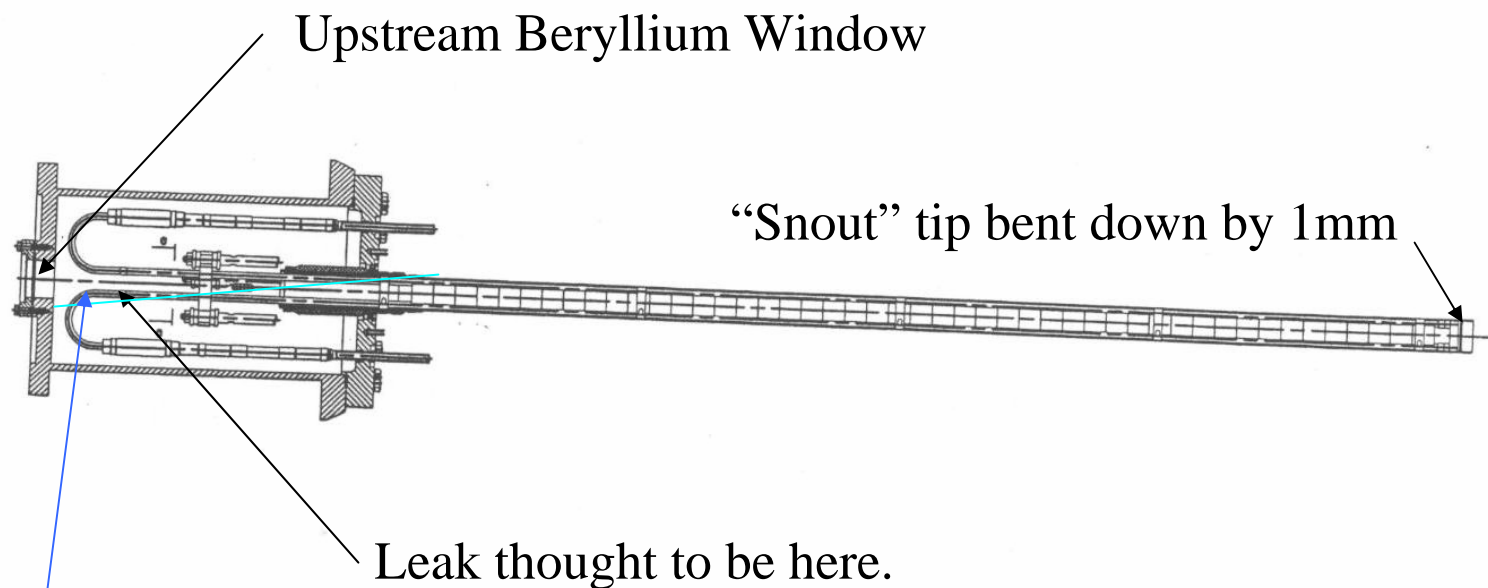
THE NuMI TARGET

Water level here when viewed with optical probe.

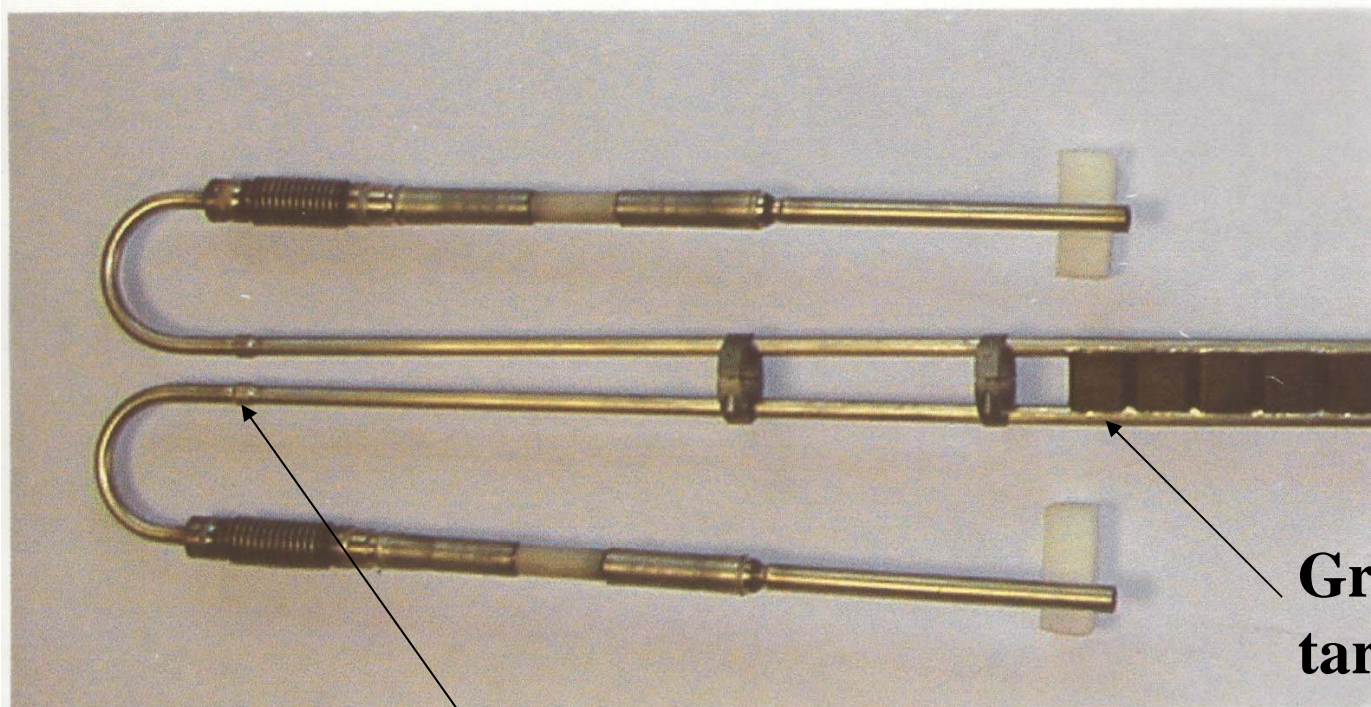
The NuMI Target

**Graphite
target tiles**

Leak thought to be here
